## **MEMORANDUM**

**To:** Melissa Manka, Town of Westford; Dan Albrecht, CCRPC  
**From:** Evan P. Fitzgerald, CPESC, CFM and Joe Bartlett, CFM  
**Re:** Westford Town Green Stormwater Problem Area Scoping Study  
**Date:** October 30, 2019

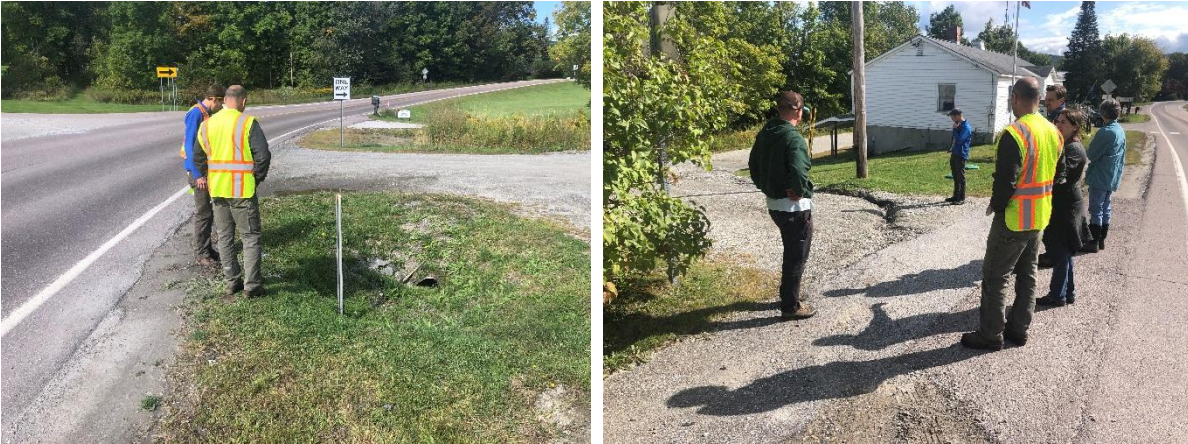
A 0.16 acre paved area drains to the deeply recessed culvert inlet near the library entrance. Sediment accumulation along the edge of pavement on Route 128 is restricting flow to the culvert. Runoff bypassing this feature continues east to the driveway between the Library and Town offices. The steep drop to the 18" culvert encroaches on the road shoulder and the parking lot and is a safety hazard along the access path to the library. The existing grade slopes slightly downward to the library entrance causing ponding and icing at the base of the ramp. Excess runoff along the front of the Library and additional runoff from Route 128 cause rilling and gully erosion across and down the steep driveway between the Library and Town Offices.

Deeply recessed culvert inlet at the library entrance (left). Runoff along the front of the library causes gully erosion across and along the driveway between the Library and Town Offices (right).

Based on preliminary observations we recommend installing a deep-sump catch basin with a surface drain (Project Area 1a on map). The catch basin will receive runoff from the 15" culvert to the south and from surface runoff upslope. The catch basin would tie into the existing 18" outlet pipe draining west to the wetland. Minor grading adjustments should be implemented to address ponding at the library entrance. These drainage improvements will significantly reduce runoff volumes to the driveway between the Library and Town Offices. The frequency and severity of erosion along this driveway should be reduced, however we recommend installation of a stabilized swale (with stone or permanent turf reinforcement mats) to convey runoff along the western edge of the driveway (see Project Area 1b on map). The driveway has an approximate width of 15 feet, leaving room to fit a 3-4 foot wide swale while maintaining a drive width of approximately 12 feet. Alternatively, if the erosion and maintenance problems persist after these improvements, the Town could consider other options to avoid this stormwater problem. This could include abandoning this access and making this area a green space to absorb and infiltrate stormwater runoff.

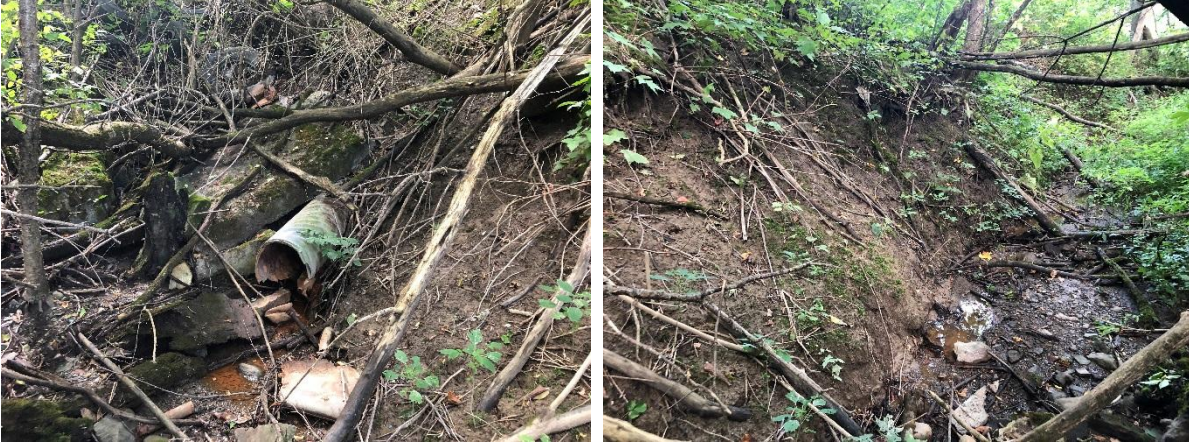
An 18" corrugated metal culvert collecting runoff from the Town Green underdrain system and surface drainage along Route 128 discharges to an incised and eroding channel flowing north to the Browns River. The outlet end of the pipe appears to be corroded and in poor condition. The erosion in the swale is moderate to severe, exceeding 4-5 feet on the banks in some locations and extending approximately 100 feet to the north of the outlet.

Outlet of 18" culvert in poor condition (left) and erosion in swale to Browns River (right)

Implementation of Project 4 will significantly reduce flows to this channel. Installation of a series of stone check dams is recommended in the outlet channel to slow flows during storm events, prevent further incision, and reduce bank erosion.

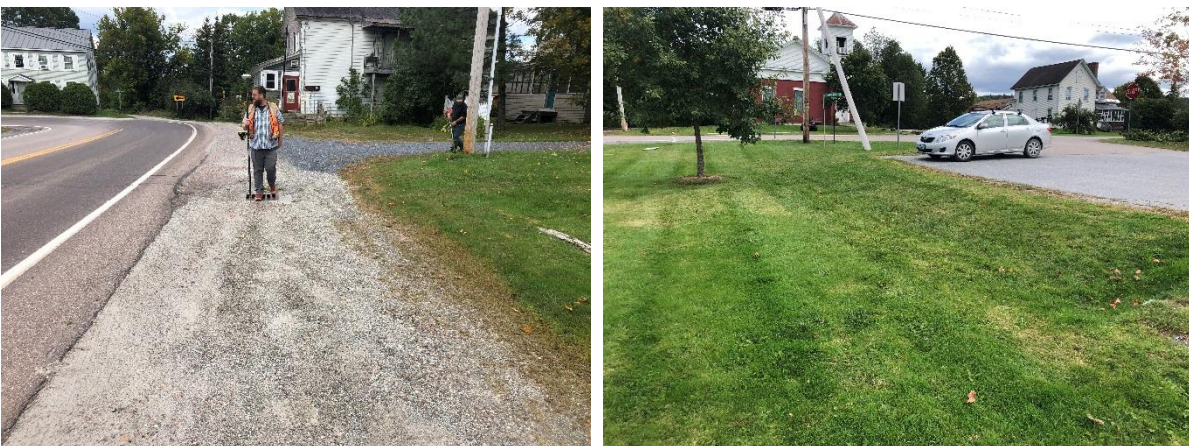
A shallow catch basin on Route 128 drains a 0.45-acre watershed including most of the Red Brick Meeting House property. The catch basin is filled with coarse sand and gravel to the top of the outlet culvert, draining west to another shallow catch basin located on the east side of the Green. This catch basin is also filled with sediment and is connected directly to the underdrain system.

Catch basin along Route 128 (left) and grassed swale that could receive redirected runoff (right)

Both catch basins need to be cleaned out and the eastern catchbasin (VTrans ROW) could be replaced with a deep-sump catch basins to improve sediment retention. The western catch basin in the Green should be retrofitted to cap the existing outlet thereby disconnecting this flow from the underdrain system. Installation of a new outlet culvert from this catch basin would convey all runoff southwest to the grassed swale along the parking area.

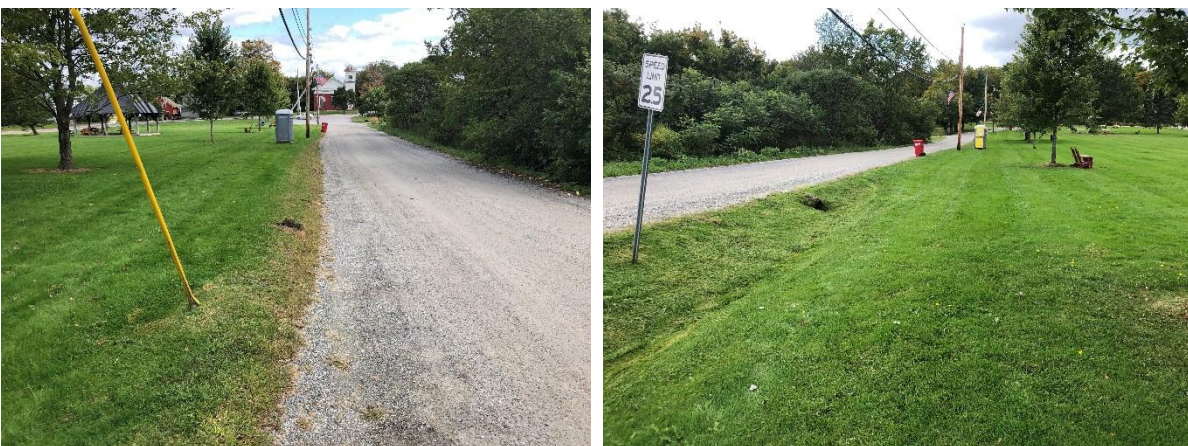
Much of Common Road lacks proper stormwater drainage leading to secondary ditch formation and rill erosion along both sides of the road. The northern half of the road, including the park and ride drain to a grassed swale leading to an 18" culvert under Common Road and into a wetland connected to the Browns River. An elevated shoulder along the northern side of Common Road causes concentrated runoff along the road edge of Common Road in an easterly direction toward the cross-culvert. The south side of the road has intermittent grader berms limiting sheet flow down the grassed slope to an existing grass swale on adjacent private property.

Looking east at elevated grass shoulder along Common Road (left) and looking west at 18" culvert inlet beneath Common Road, the potential location for a stormwater retrofit practice (right).

Grader berms and elevated shoulders should be removed to facilitate sheet flow off of the road surface. A grassed swale could be installed along the northern side of the road to collect runoff and convey flow east to the 18" cross-culvert. Alternatively, Town Staff and Officials have suggested the Town Common underdrain system could be extended to the south to collect surface and shallow groundwater from this area. However, this approach is not recommended given the known problems in the existing drainage system, and the unknown hydraulic capacity of the system to handle additional flow. An upgraded drainage system with adequate capacity could make this option viable.

The grassed area west of the park and ride adjacent to the cross-culvert inlet present an opportunity to install a stormwater gravel wetland or under-drained bioretention system treating runoff from over 1 acre of drainage area including half of Common Road, including approximately ½ acre of impervious surface.
