August 22, 2025

The Pigeon House, Westford, Vermont

A Preservation Trust of Vermont

Technical Assistance Survey

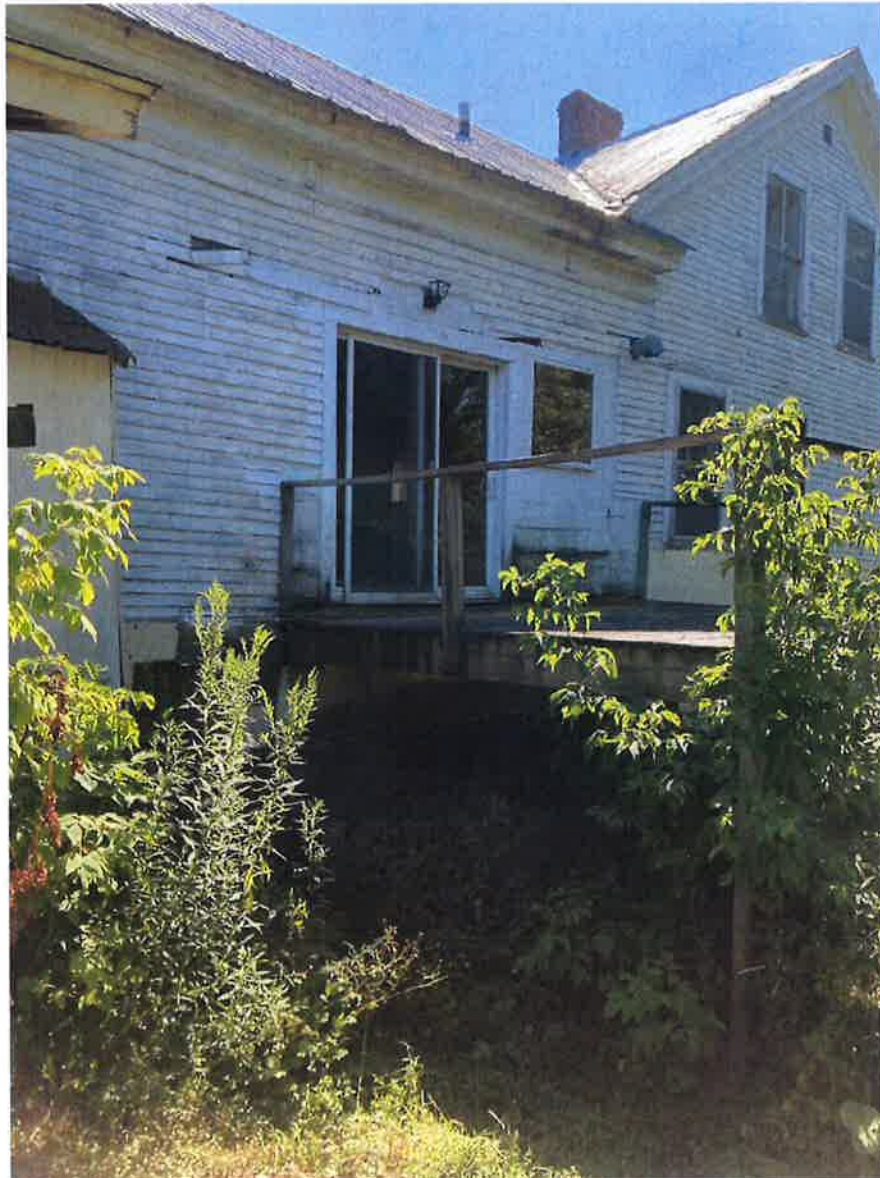
The wing has a front porch in good condition. A newer deck on the back is in catastrophic condition due to its drainage being reversed by the sinking of the rear wall of the house. An open sided garage on the south is constructed with as little

The most pressing problem in making the house habitable is the need to jack the rear of the house level for numerous feet around the junction of the main house and wing, including an area of the rear kitchen floor. This is centered on the declivity produced at the rear of the house to provide direct access to the basement door and kitchen. This ground feature dates from the earliest days of the house and undoubtedly once had better grading around it directing run off to the river valley right behind the house. Once this is done the foundation there can be rebuilt in stone or concrete, and either full height or with a timber sill and wooden wall as originally constructed. Either way you will want a door to enter the basement directly from outside, such as exists now. This foundation problem extends around the NE corner as well where even the newer concrete facing has broken and pushed inward, displacing the brick lining in the basement as well.

Pigeon House, Westford, Vt. Rear wall with failing deck and failed basement wall.

**2. Framing:** Rebuilding the rear center wall will involve removing the wooden deck which is failing, and has too high a relationship to the rear sill and floor. Once the deck is gone one can not only rebuild below, but also find out whether the main floor sill has been rotted by

splash up and infiltration by the deck and sliding glass doorway. In all cases, once jacked level, repair any sills and walls with solid softwood timber, which may involve supporting some kitchen floor joists on jacks temporarily. Once everything is straight and re-graded the deck can be rebuilt if desired along with outdoor stairs.

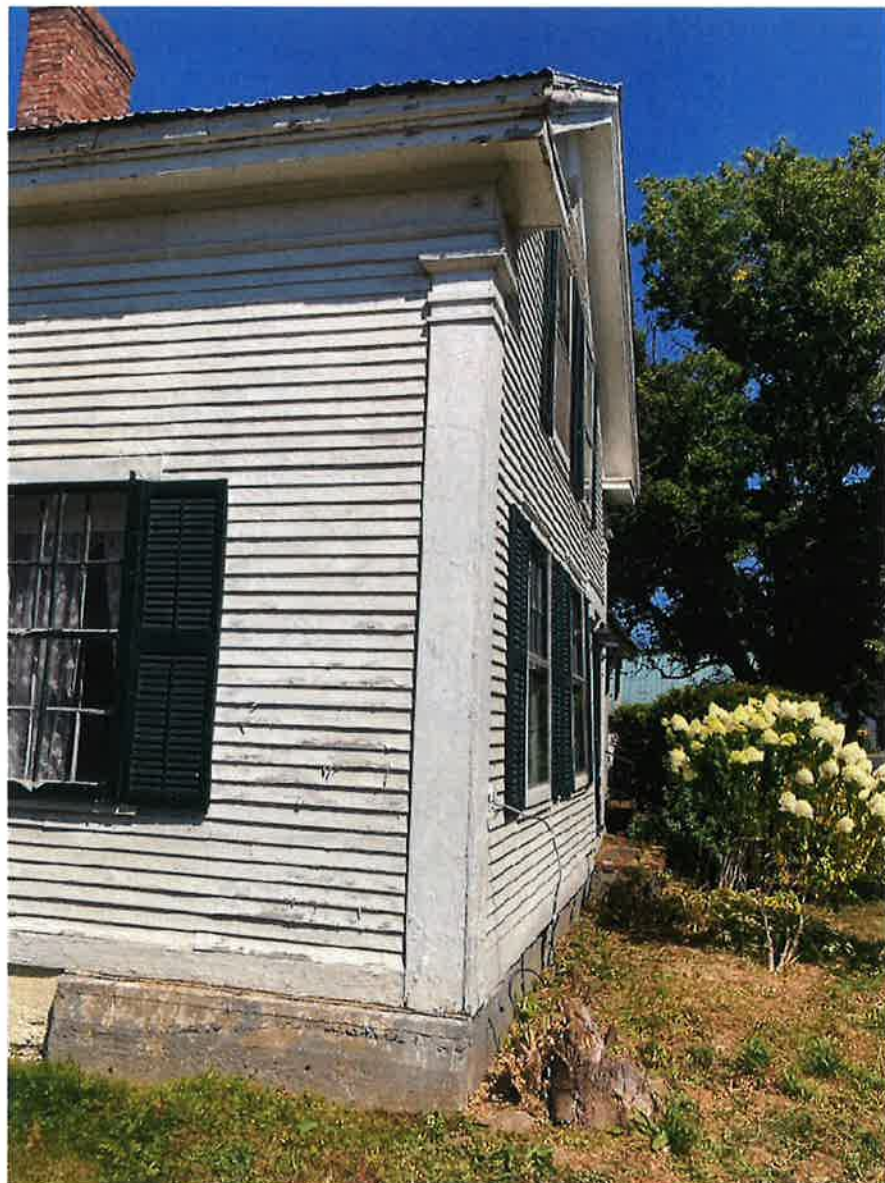
Pigeon House, NW corner with front wall slightly bowed

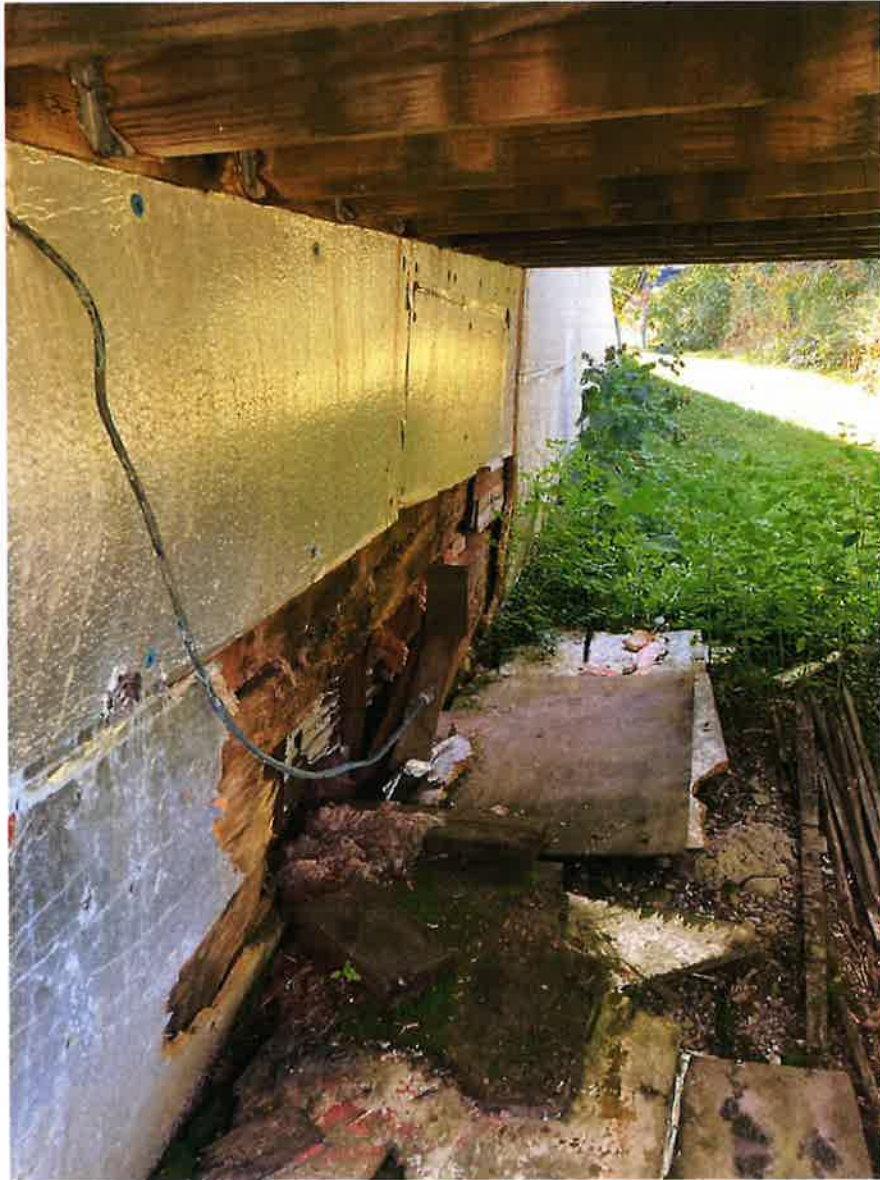
The foundation is field stone lined with brick from top to bottom, with the exception of the middle back where a wood framed wall was exposed. The north foundation has been reinforced with concrete as have some other threatened sections, testifying to the poor drainage on the clay soil in this town. The floor of the basement is dirt with some concrete under the oil furnace and hot water heater. A large, newer brick and block chimney rises along the mid wall interior and serves the basement appliances plus wood stoves that until recently existed. The

When you uncover the entire rear basement wall, some of which is concealed with styrofoam insulation, you may find the entire rear wall needs some jacking. This is suggested not only by the kitchen floor but also the

Pigeon House: failed rear wooden  
basement wall

1. Foundation and Drainage: Jack the rear wall of the house level and rebuild the foundation and missing middle section full height wall as needed.

2. Framing: If you choose not to construct a full height masonry foundation you will need to lay a timber sill and frame a wall where it previously and originally existed at the middle rear.

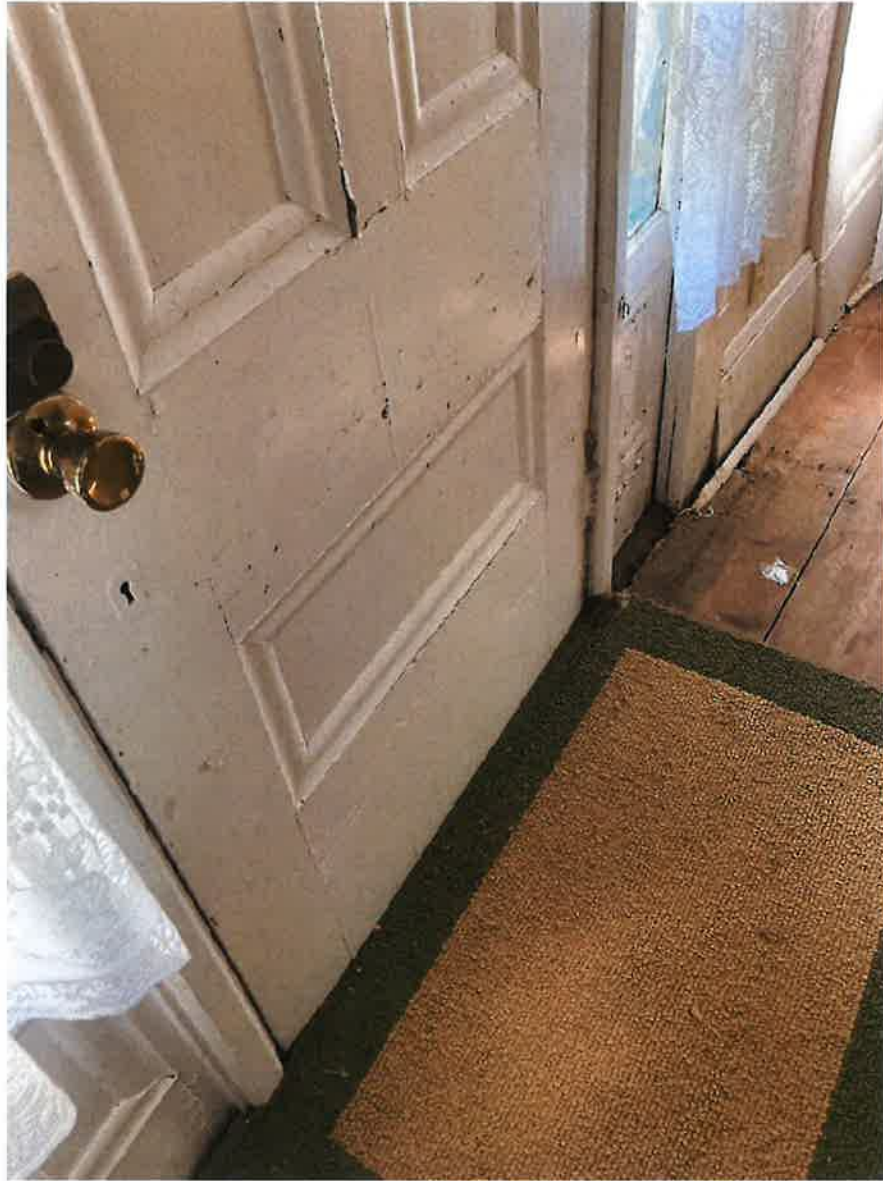
Out of plumbness in the lower part of the main house walls around the front door strikes me as an old and hopefully stable problem. If you lift with a jack on the main house SW corner post (first removing some of the pilaster boarding), you will be able to dismantle the falling brick at the bottom of the basement stairs and hopefully see the condition of the sill joint at that corner.

Pigeon House: old problem at front door sill and foundation.

Install drainage. Examine the foundation under the Main House door.

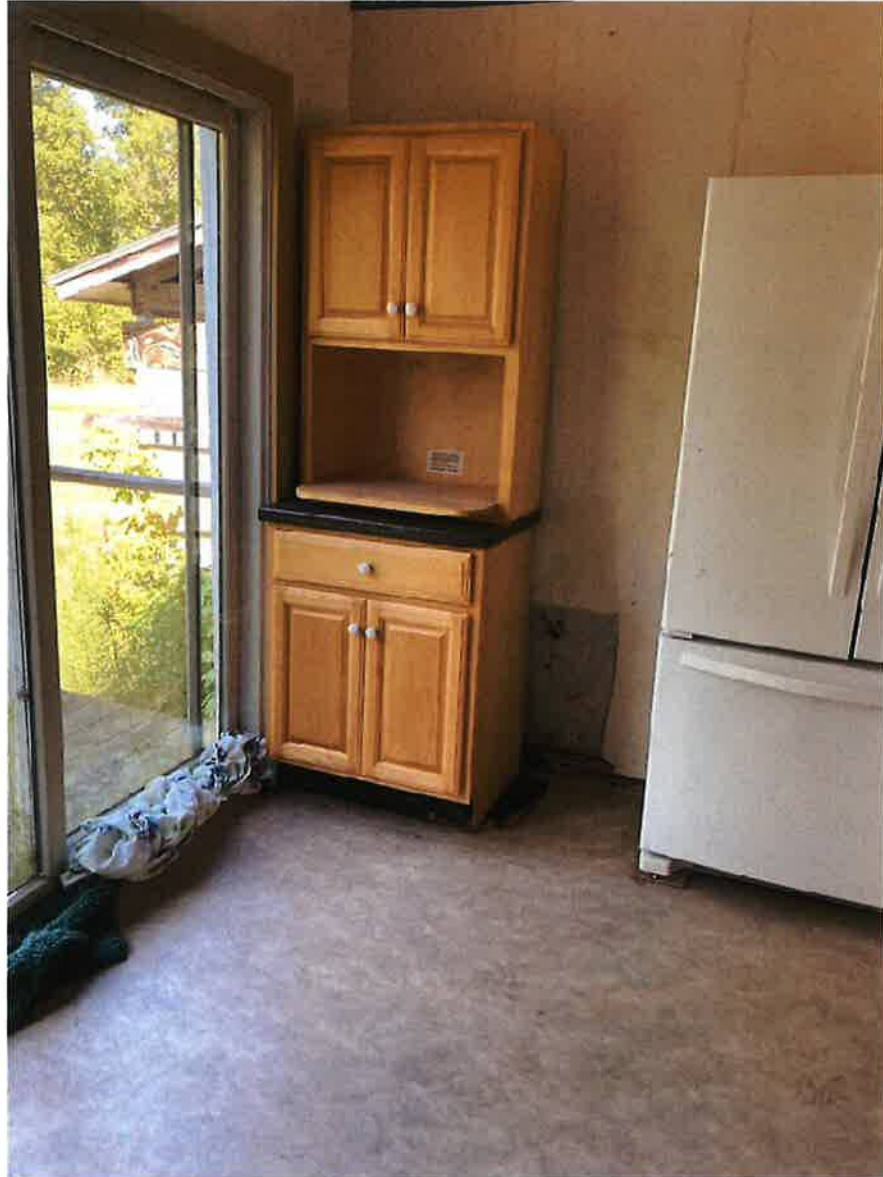
Other than along the rear wall, the house appears relatively square, plumb and well maintained. The kitchen, now in the wing, is new with new appliances but suffering from the sinking back wall and deck. There is one recent bathroom with a shower. Heat is by hot water running to

depression of the floor in the small room at the rear of the wing. This will improve the leveling of the floors throughout the house, where the medial wall appears slightly higher than the front or rear walls.

Pigeon House: Westford, Vt. Kitchen  
floor dropping at failed rear wall

Also, the rear main sill of the house may be rotted at the glass doors and to either side beyond. Repair this in solid timber while supporting the floor joists and the wall on jacks

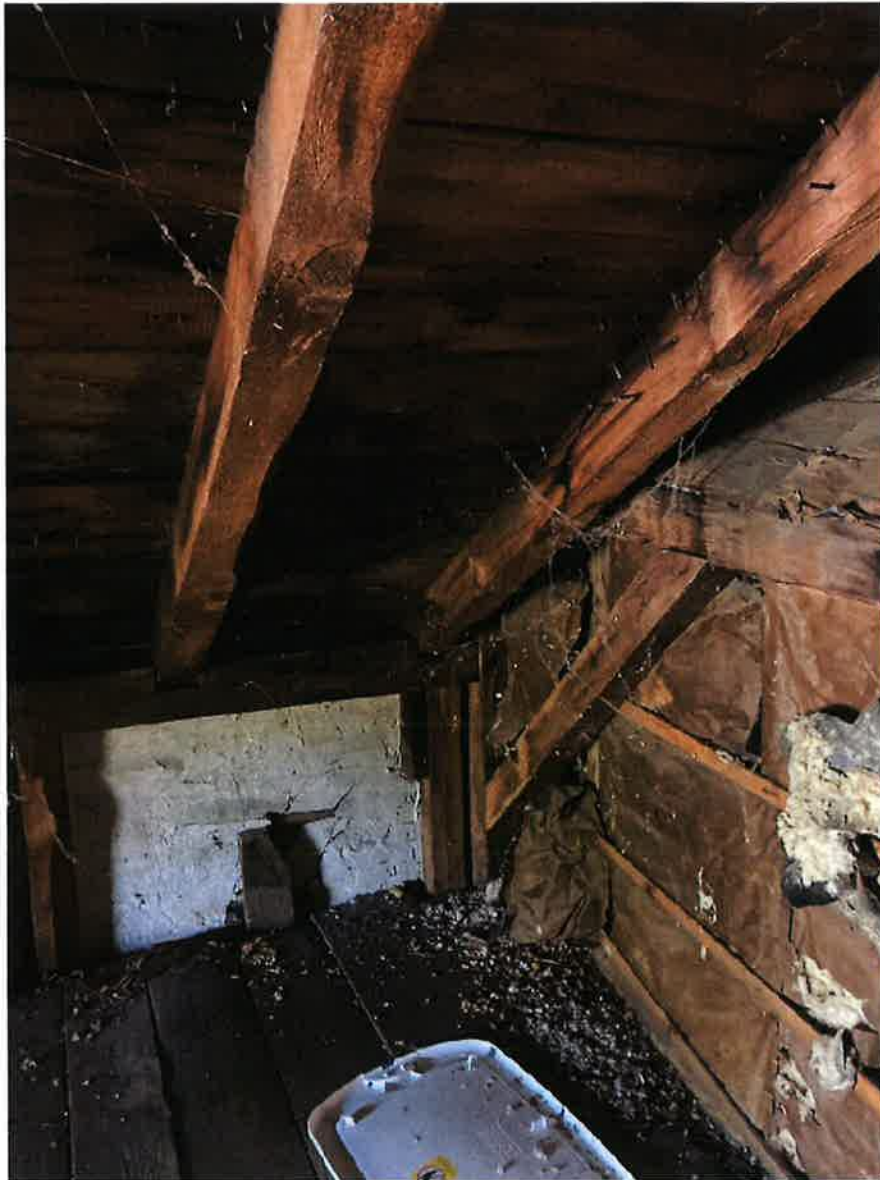
The house and wing are timber framed in the light weight style of the time meant to conceal the frame: 4 x 4 and 4 x 6 wall studs, 5 x 6 rafter plates and 4 x 4 rafters 30 inches o.c. The floor framing seen from the basement is heavier with 8 x 9 carrying beams and 3 x 6 joists. All the timber appears to be hemlock, and vertically sawn. The date of the house is probably around 1850, although the inclusion of a bake oven and basement kitchen in a village home is unusual at this late date. The frame can be viewed in the undeveloped 2nd floor of the wing and appears very good.

At certain points fiberglass insulation can be seen in the basement ceiling and house walls, but the completeness is unknown and perhaps can be discovered by asking the former occupants.

Pigeon House : timber framing and insulation as seen the attic of the Wing

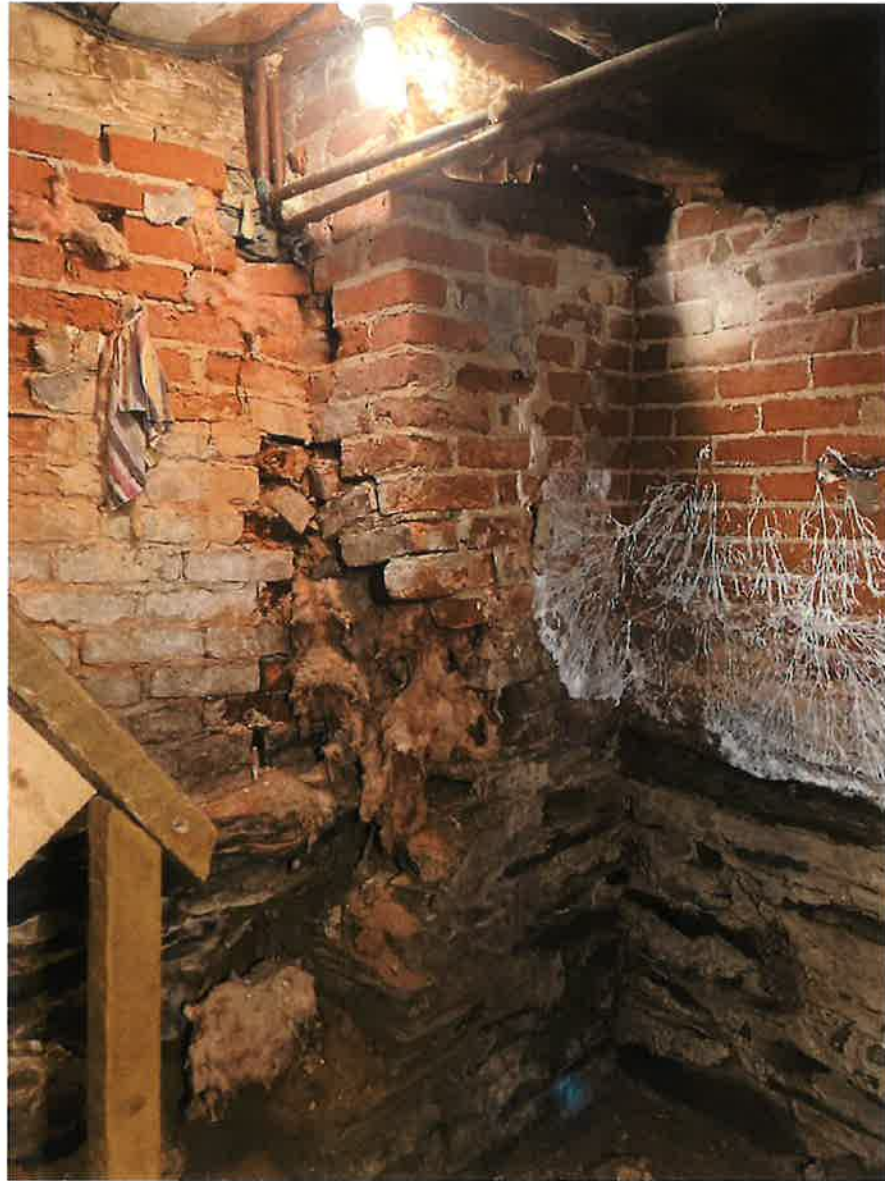
Pigeon House, Westford, Vt. :  
foundation problems under the front  
main door at SW corner of Main House

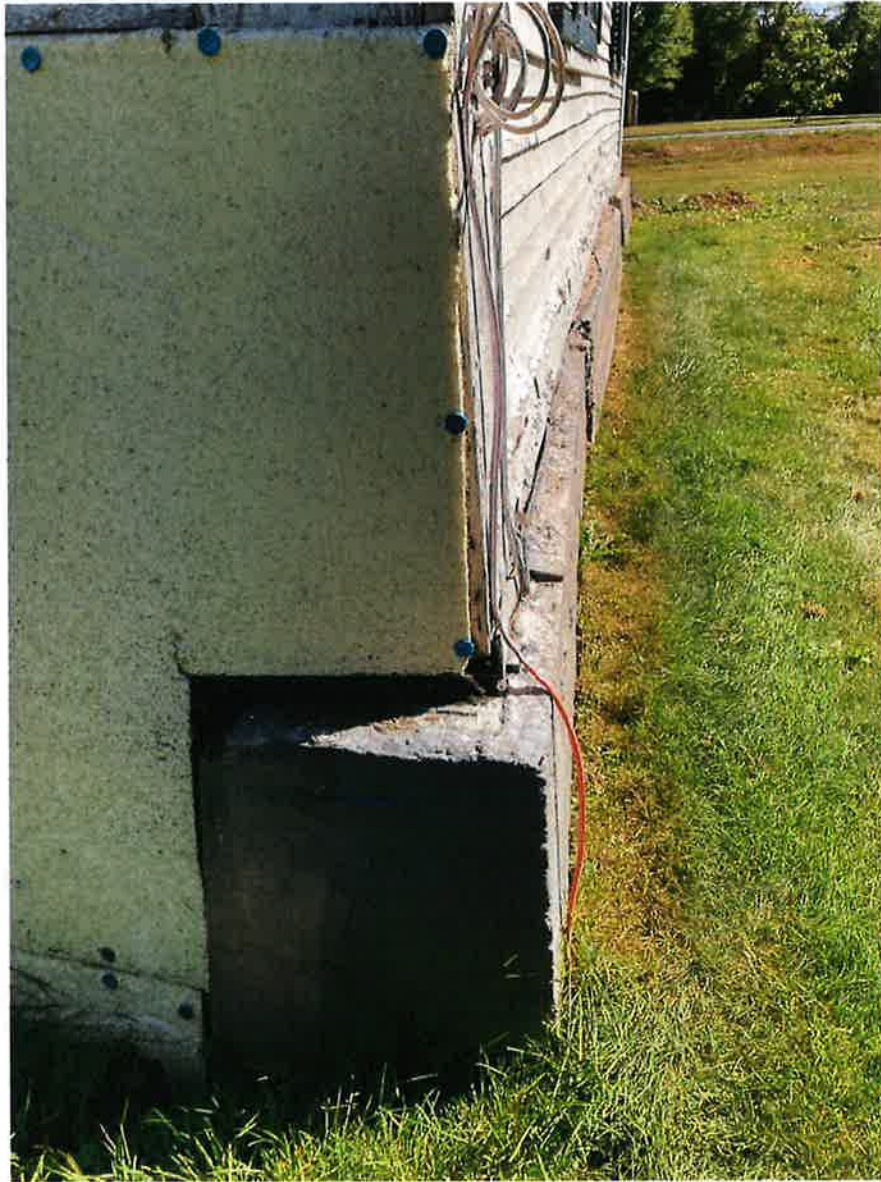
6. Exterior Trim and Finish: The main area in need of work is the rear wall around the new sliding glass doors and window, where clapboards were removed and never replaced. Right above there is evidence of cornice and soft damage under the metal valley. Also the area under the styrofoam insulation on the back wall probably needs re-clapboarding and trim work (see photo of missing parts of the

corner pilaster base), including the rebuilt portion if done in wood.

Pigeon House, Westford, Vt. NE corner at rear with deteriorating trim and siding

6. Exterior Trim and Finish: Trim and clapboard replacement on the rear upper and lower walls.
