August 22, 2025

The Pigeon House, Westford, Vermont

A Preservation Trust of Vermont

Technical Assistance Survey

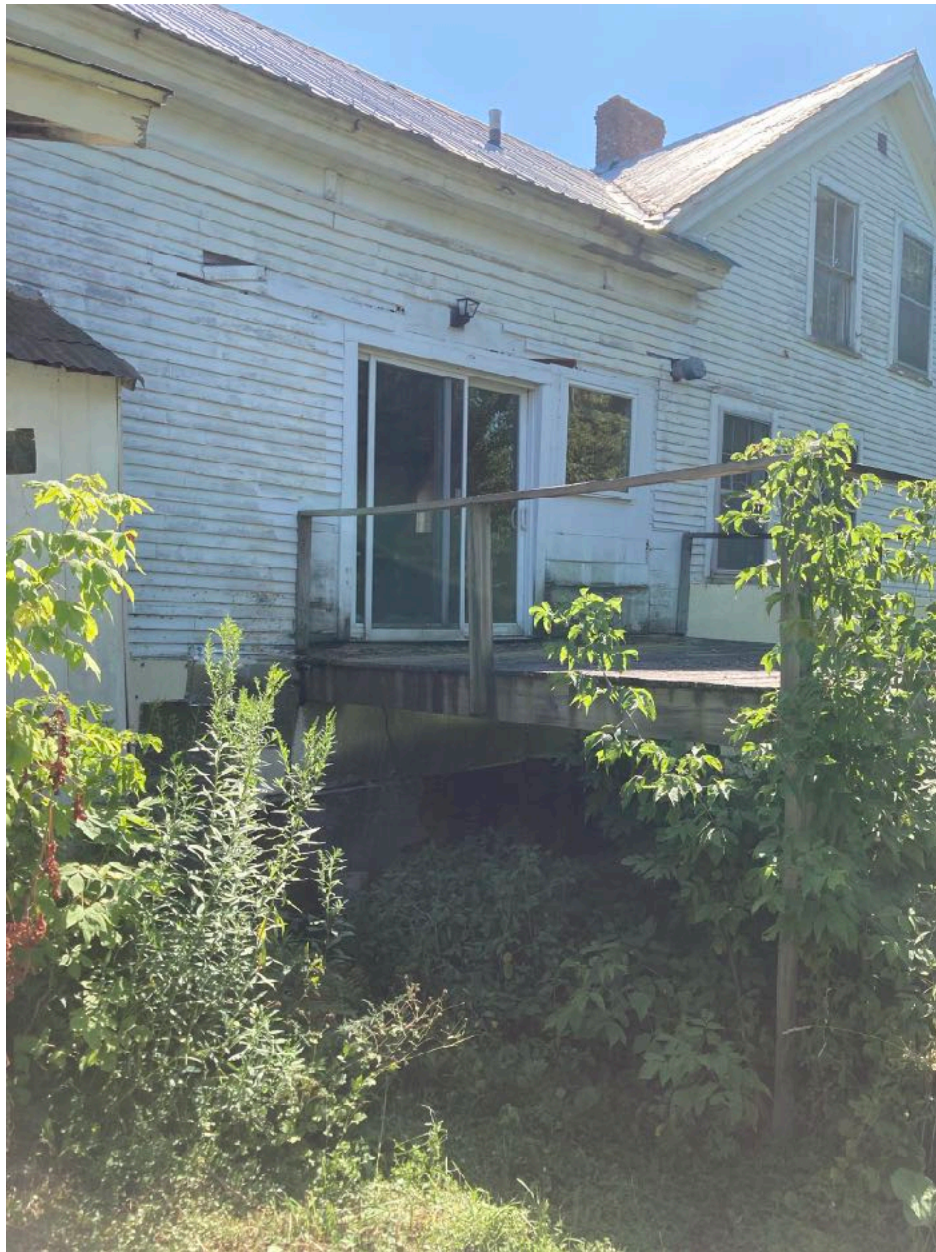
The wing has a front porch in good condition. A newer deck on the back is in catastrophic condition due to its drainage being reversed by the sinking of the rear wall of the house. An open sided garage on the south is constructed with as little

The most pressing problem in making the house habitable is the need to jack the rear of the house level for numerous feet around the junction of the main house and wing, including an area of the rear kitchen floor. This is centered on the declivity produced at the rear of the house to provide direct access to the basement door and kitchen. This ground feature dates from the earliest days of the house and undoubtedly once had better grading around it directing run off to the river valley right behind the house. Once this is done the foundation there can be rebuilt in stone or concrete, and either full height or with a timber sill and wooden wall as originally constructed. Either way you will want a door to enter the basement directly from outside, such as exists now. This foundation problem extends around the NE corner as well where even the newer concrete facing has broken and pushed inward, displacing the brick lining in the basement as well.

Pigeon House, Westford, Vt. Rear wall with failing deck and failed basement wall.

This straightening of the back wall will render the house more habitable, but will only be a temporary solution until the rear yard is excavated to a new grade profile directing runoff away. At the same time the entire house should have perimeter drainage installed to allow other parts of the basement walls to be straightened with some hope of them staying that way, including the displacement of foundation and wooden wall around the front doorway, which is not of recent origin. The slope dropping off to the river immediately behind the house allows plenty of opportunity to run drainage to daylight.

2. Framing: Rebuilding the rear center wall will involve removing the wooden deck which is failing, and has too high a relationship to the rear sill and floor. Once the deck is gone one can not only rebuild below, but also find out whether the main floor sill has been rotted by

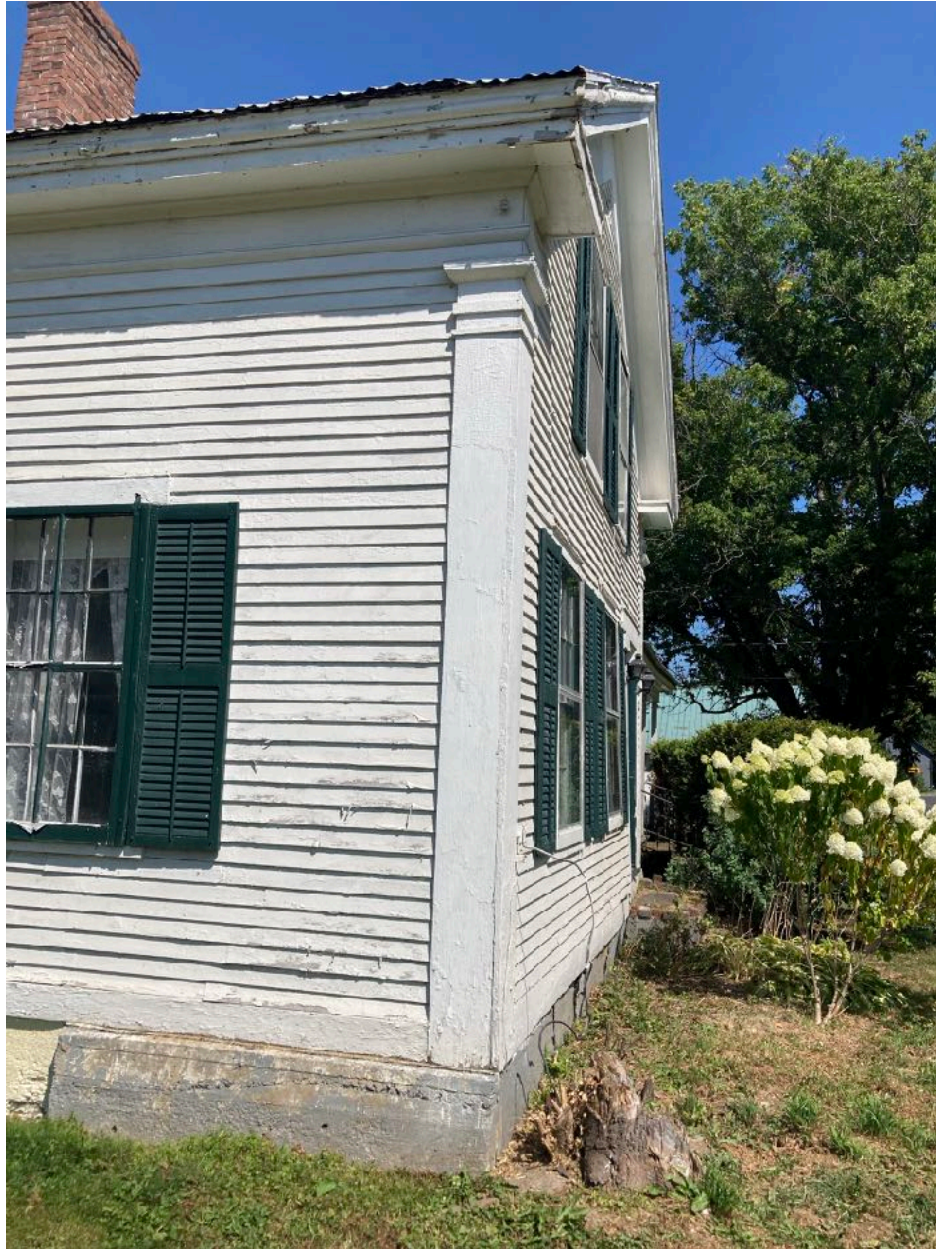
Pigeon House, NW corner with front wall slightly bowed

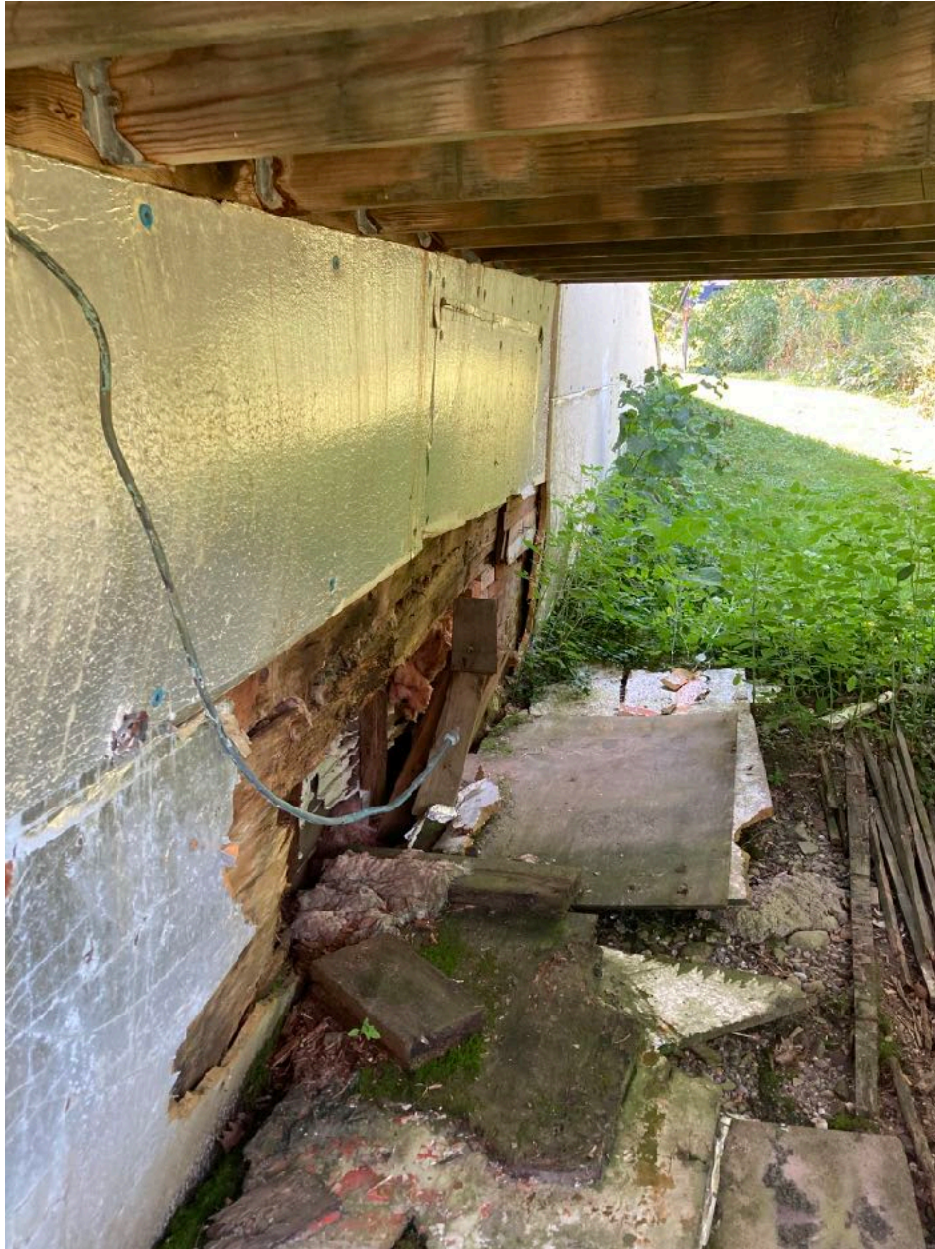
Pigeon House: failed rear wooden basement wall

2. Framing: If you choose not to construct a full height masonry foundation you will need to lay a timber sill and frame a wall where it previously and originally existed at the middle rear.

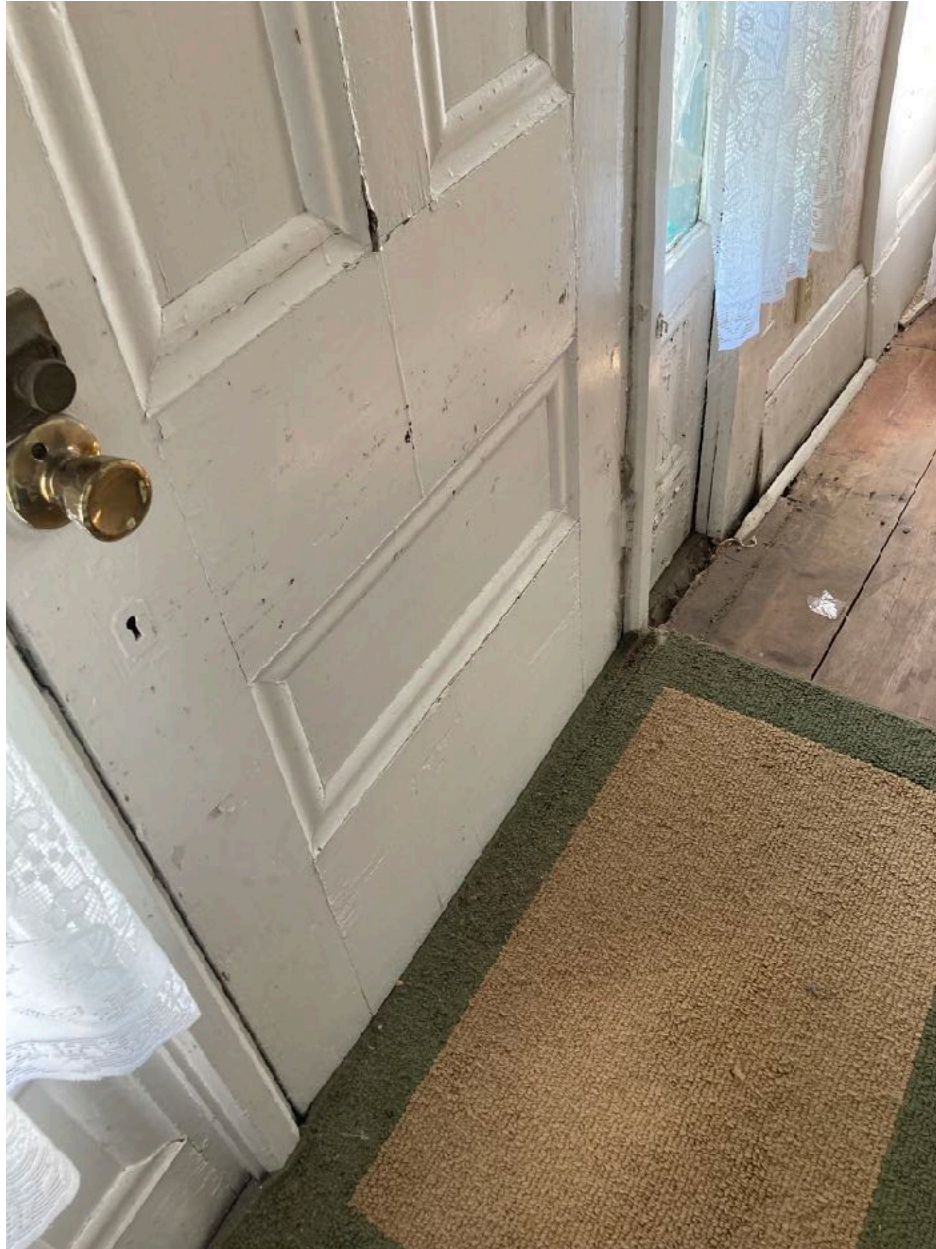
Out of plumbness in the lower part of the main house walls around the front door strikes me as an old and hopefully stable problem. If you lift with a jack on the main house SW corner post (first removing some of the pilaster boarding), you will be able to dismantle the falling brick at the bottom of the basement stairs and hopefully see the condition of the sill joint at that corner.

Pigeon House: old problem at front door sill and foundation.

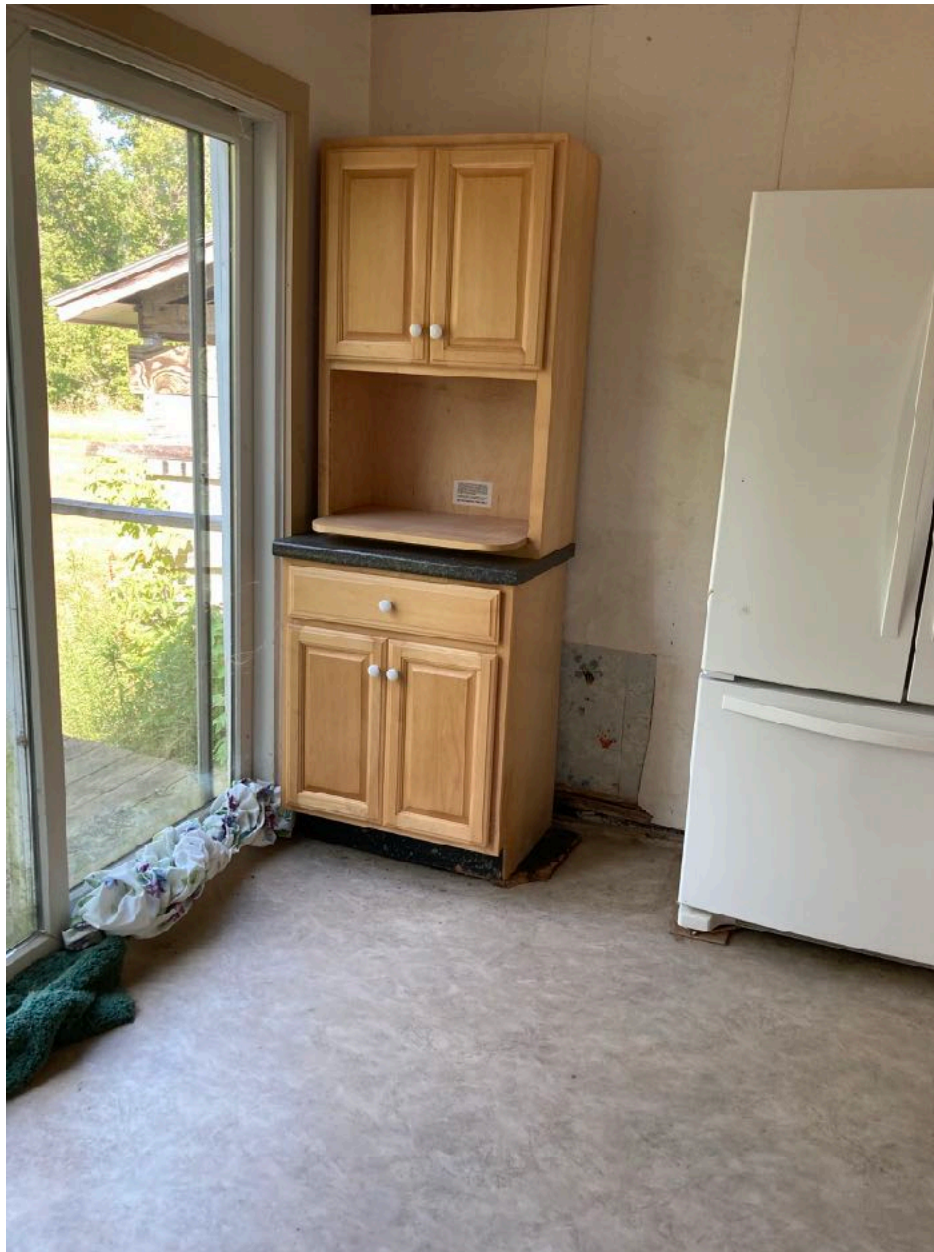
When you uncover the entire rear basement wall, some of which is concealed with styrofoam insulation, you may find the entire rear wall needs some jacking. This is suggested not only by the kitchen floor but also the

depression of the floor in the small room at the rear of the wing. This will improve the leveling of the floors throughout the house, where the medial wall appears slightly higher than the front or rear walls.

Pigeon House: Westford, Vt. Kitchen floor dropping at failed rear wall

splash up and infiltration by the deck and sliding glass doorway. In all cases, once jacked level, repair any sills and walls with solid softwood timber, which may involve supporting some kitchen floor joists on jacks temporarily. Once everything is straight and re-graded the deck can be rebuilt if desired along with outdoor stairs.

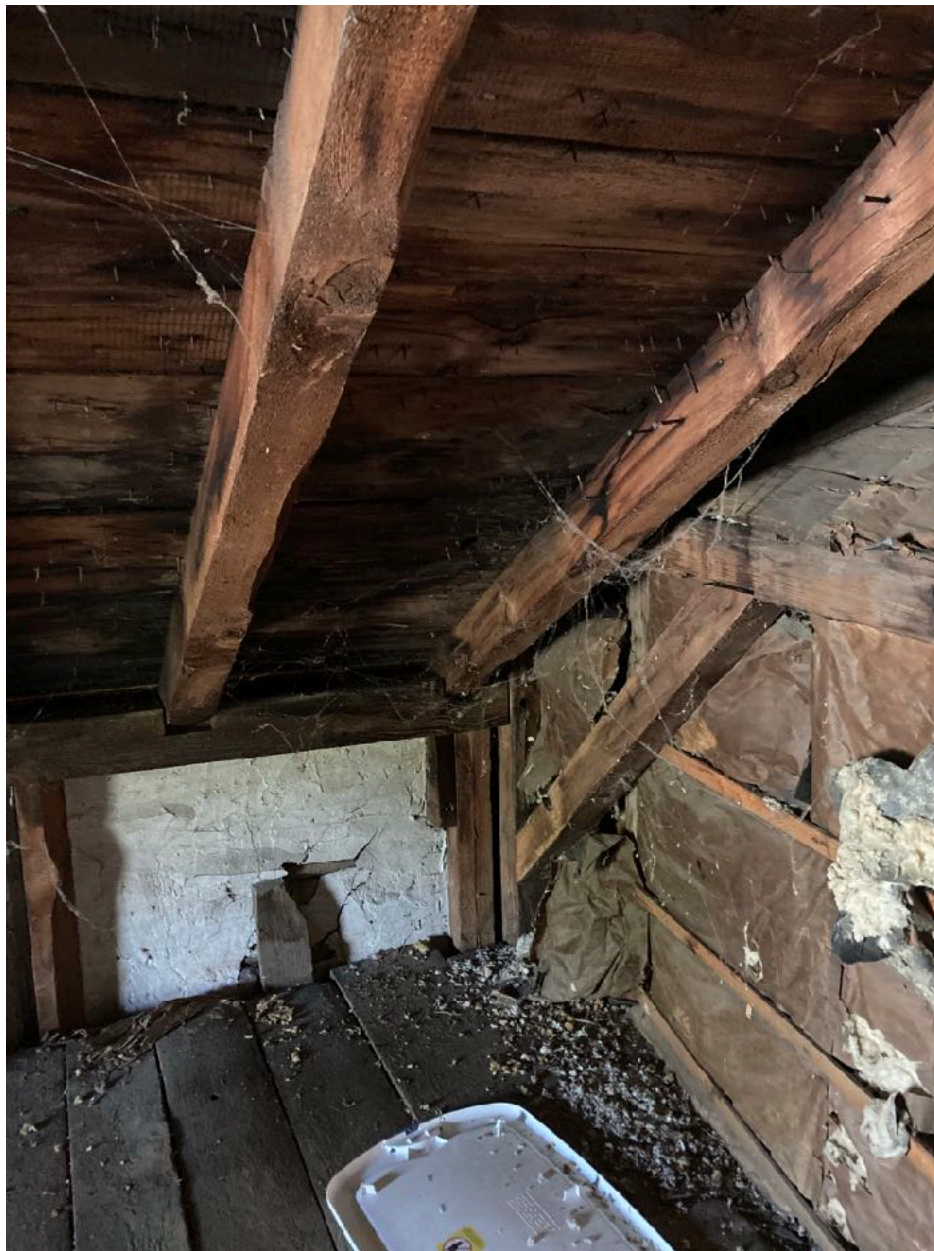
The house and wing are timber framed in the light weight style of the time meant to conceal the frame: 4 x 4 and 4 x 6 wall studs, 5 x 6 rafter plates and 4 x 4 rafters 30 inches o.c. The floor framing seen from the basement is heavier with 8 x 9 carrying beams and 3 x 6 joists. All the timber appears to be hemlock, and vertically sawn. The date of the house is probably around 1850, although the inclusion of a bake oven and basement kitchen in a village home is unusual at this late date. The frame can be viewed in the undeveloped 2nd floor of the wing and appears very good.

Pigeon House : timber framing and insulation as seen the attic of the Wing

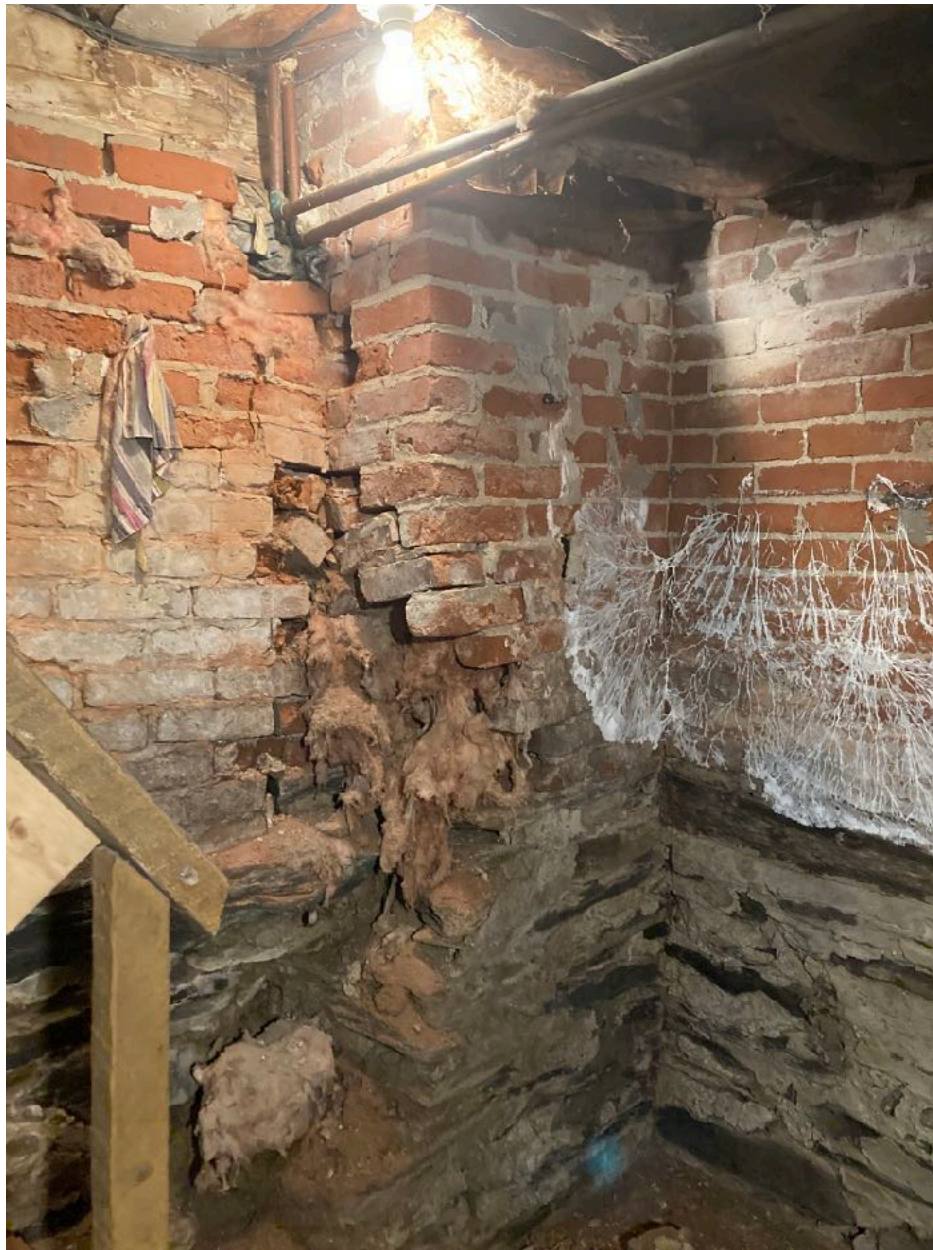
Pigeon House, Westford, Vt. :
foundation problems under the front
main door at SW corner of Main House

Install drainage. Examine the foundation under the Main House door.

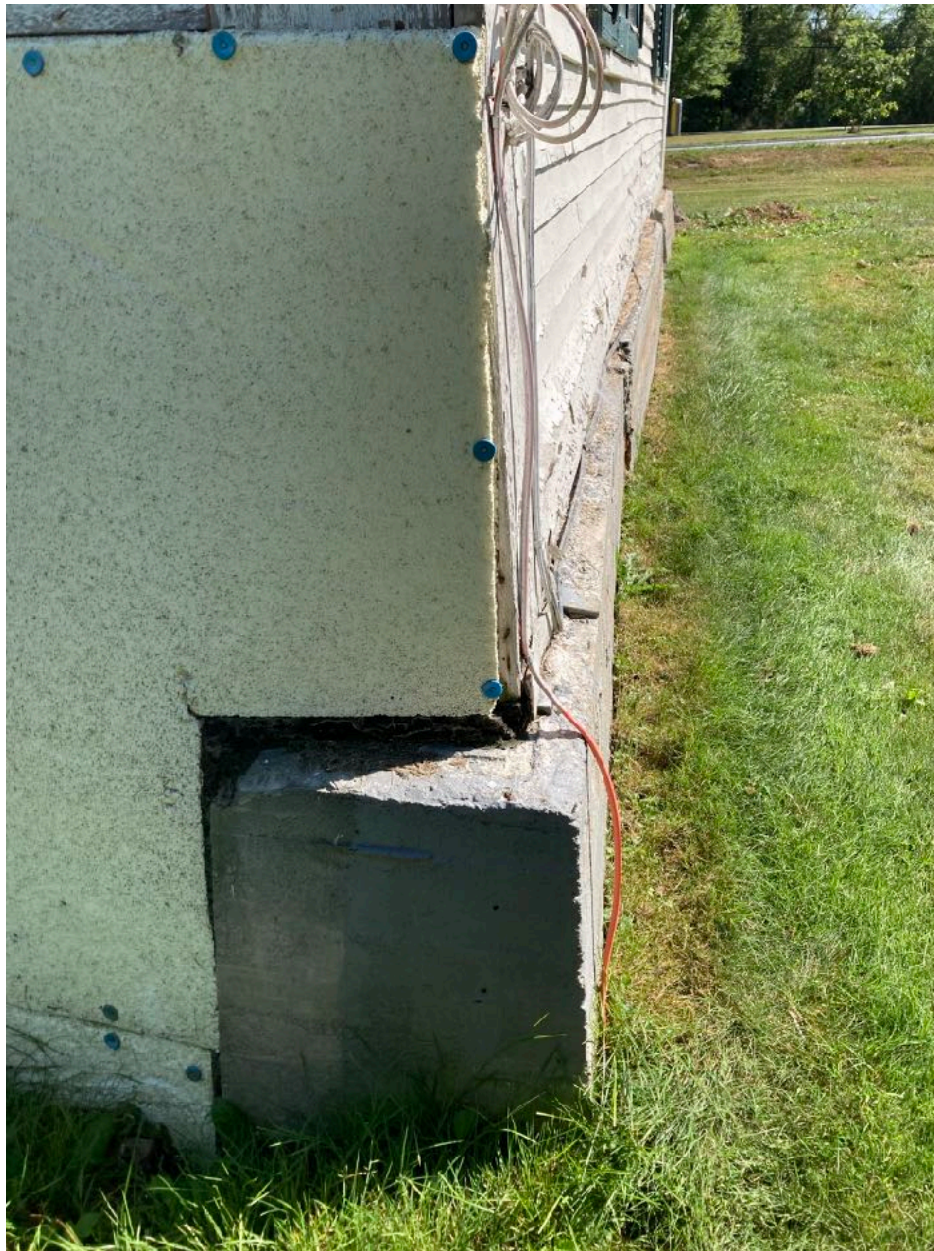
6. Exterior Trim and Finish: The main area in need of work is the rear wall around the new sliding glass doors and window, where clapboards were removed and never replaced. Right above there is evidence of cornice and soft damage under the metal valley. Also the area under the styrofoam insulation on the back wall probably needs re-clapboarding and trim work (see photo of missing parts of the

corner pilaster base), including the rebuilt portion if done in wood.

Pigeon House, Westford, Vt. NE corner at rear with deteriorating trim and siding

6. Exterior Trim and Finish: Trim and clapboard replacement on the rear upper and lower walls.
