2025 Groundwater Monitoring Report

Pigeon Property
1705 Route 128
Westford, Vermont

DEC SMS#2019-4863

June 17, 2025

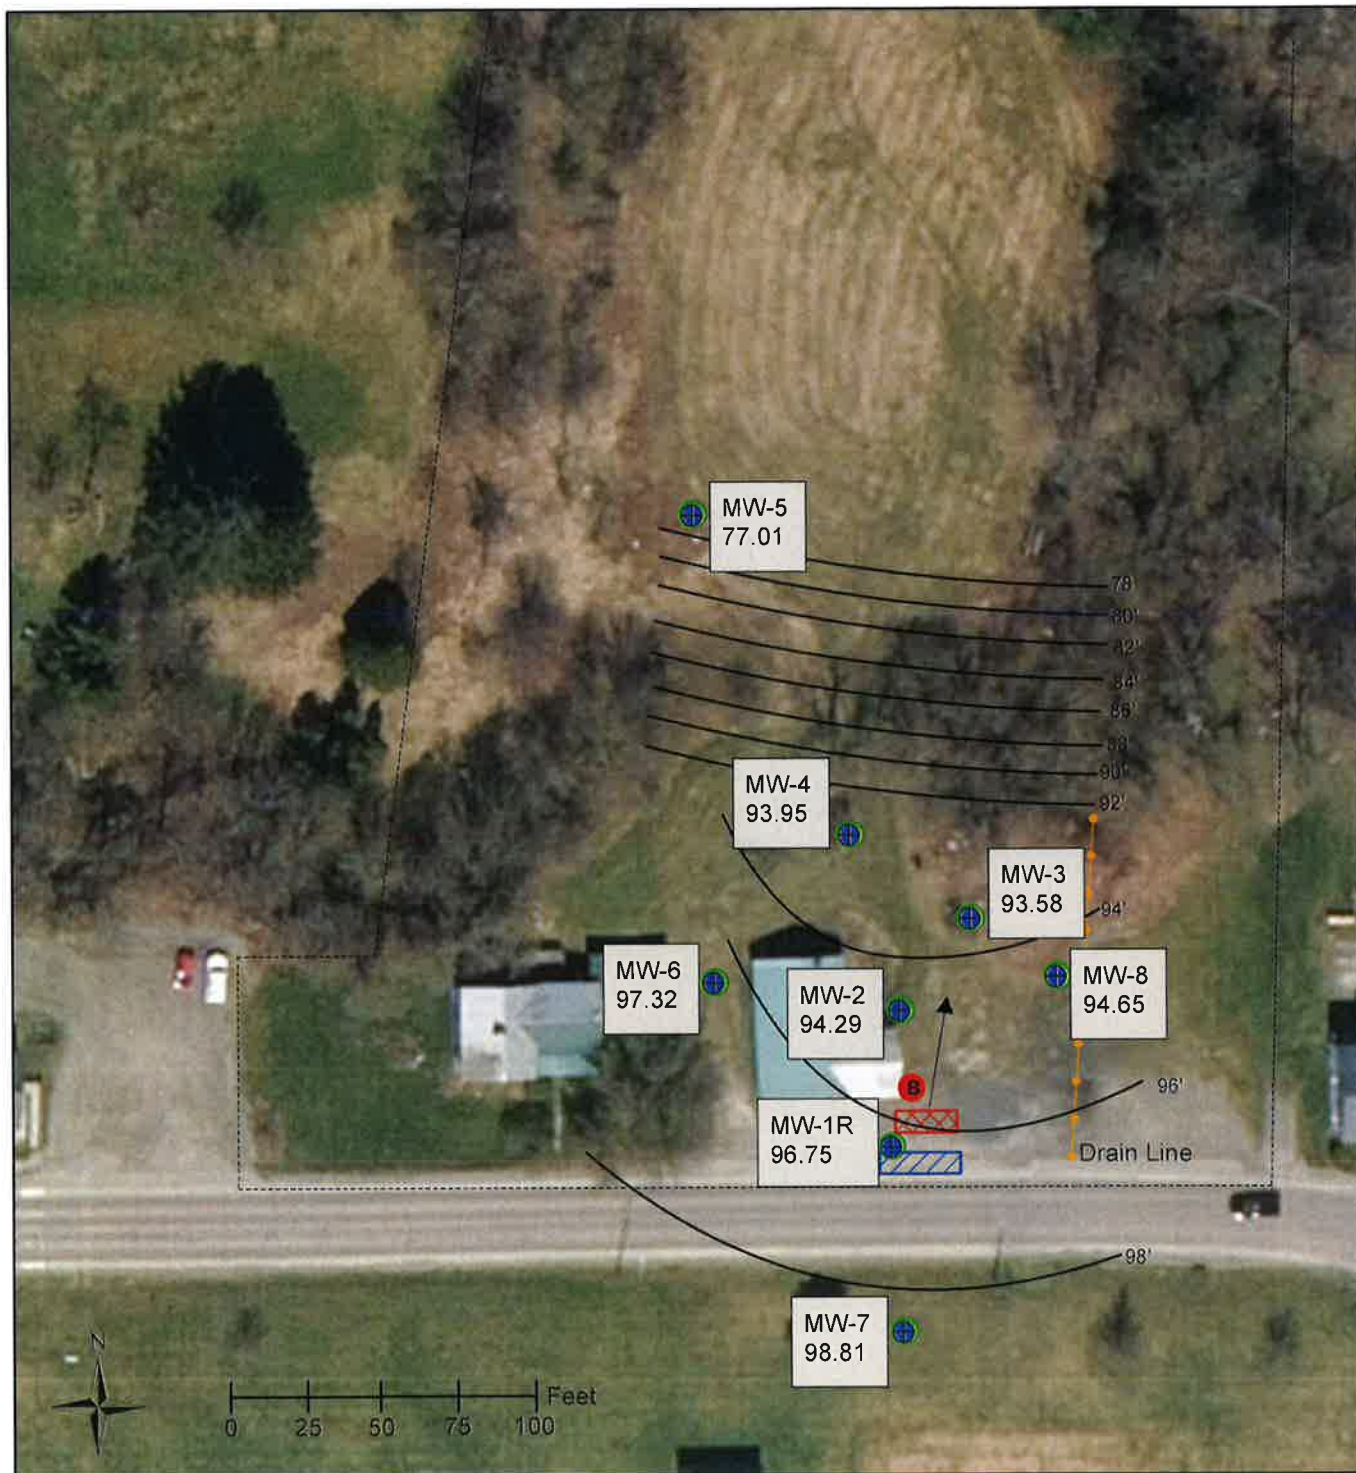
Groundwater Contour Map Pigeon Property 1705 Route 128 Westford, Vermont LEE Project # 19-138

The calculated relative groundwater elevations were plotted to create the Groundwater Contour Map in Appendix A. The overall groundwater flow during this sampling event was determined to be to the northeast. The approximate hydraulic gradient was approximately 4% on the southern portion of the Site and 20% in the central and northern portions of the Site. This groundwater flow and gradient are similar to those observed in the previous sampling events.

- Monitoring well-elevations in feet
 - ↑ Arrow denotes approximate groundwater flow
 - ⊠ Gasoline UST Pulled 2020
 - ⊠ Gasoline UST Pulled 2022
 - Ⓟ Benchmark 100'
- Measure Date: 5/6/25
Drawing Date: 6/5/25

2. The approximate hydraulic gradient was approximately 4% on the southern portion of the Site and 21% in the central and northern portions of the Site.

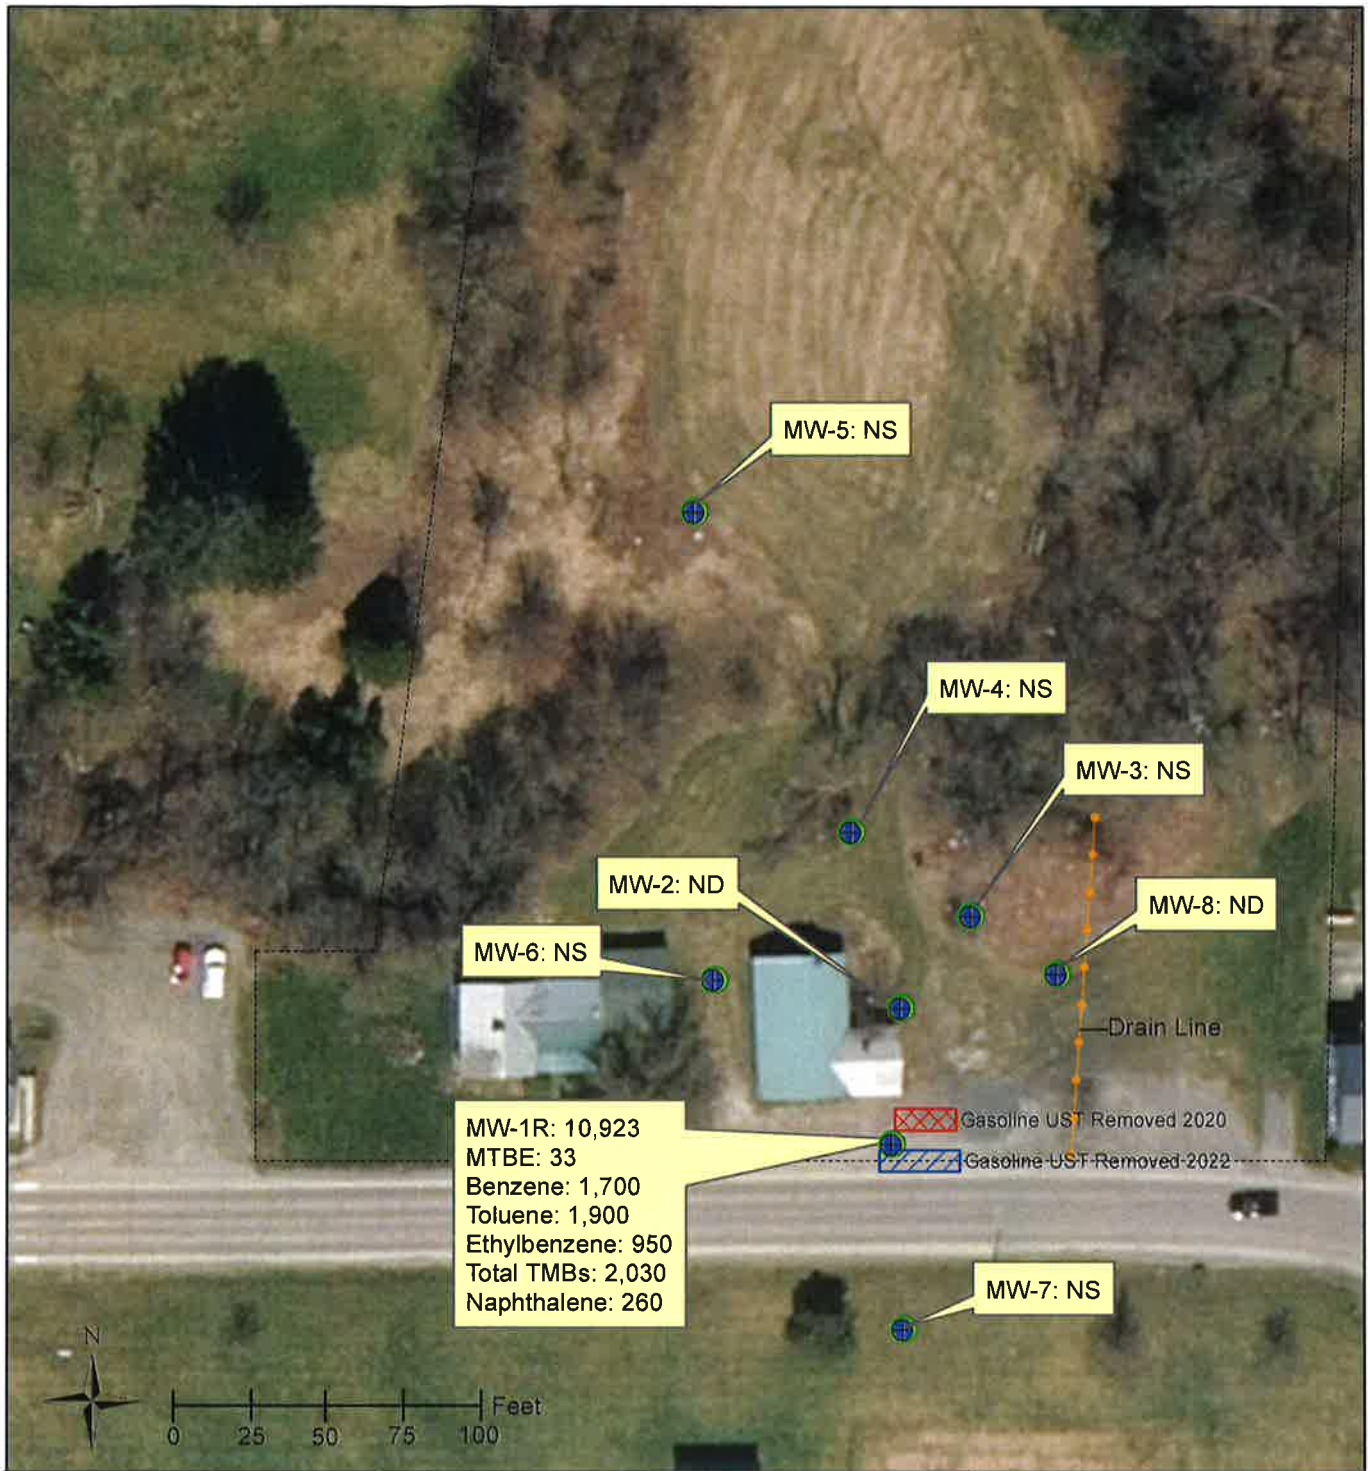
Groundwater Contaminant Concentration Map Pigeon Property 1705 Route 128 Westford, Vermont LEE Project # 19-138

The most recent monitoring event revealed contaminant concentrations were confined to the former UST grave area (MW-1R). The dissolved contamination plume previously extended to MW-2 to the north, MW-6 to the northwest, and MW-8 to the northeast. The magnitude of contamination in this area has decreased by 86% since the first sampling event in June 2020, and by 81% since the sampling event prior to soil removal. Contaminant concentrations remain above the VGES for MTBE, benzene, toluene, ethylbenzene, trimethylbenzenes, and naphthalene at MW-1R. The contaminant concentrations decreased since the most recent sampling event in April 2024 and the total VOCs concentration was the lowest reported to date. The overall decreasing trend is expected continue via natural attenuation in the source area.

Downgradient monitoring wells MW-3, MW-4, MW-5, and MW-6 were previously found to not be impacted from the groundwater contaminant plume. Monitoring well MW-7, which was installed on the Westford Common, is upgradient from the Site and has not had contaminant concentrations detected above laboratory reporting limits. Based on this information, the limits of the plume have been fully defined. Dissolved contaminant concentrations are expected to continue decreasing via natural attenuation now that the sources have been removed from the Site. A Groundwater Contaminant Map indicating the dissolved-phase petroleum VOC contaminant concentrations is included in Appendix A.

- GW Monitoring Well with total VOCs concentrations (ug/L)
- Regulatory exceedances in call-out boxes
- ND = Non-Detect
- Sampled via EPA Method 8260
- VT Petroleum List
- Sample Date: 5/6/25
- Drawing Date: 6/5/25

1. LEE recommends biennial groundwater monitoring occurs in the Spring of 2027 to track contaminant concentrations in the vicinity of MW-1R. The sampling schedule should continue to include sampling MW-1R, MW-2, and MW-8. LEE also recommends properly abandoning the Site monitoring wells that are no longer sampled.
